# *Operation* **UPSHOT-KNOTHOLE** NEVADA PROVING GROUNDS

EFFECTS OF AN ATOMIC EXPLOSION ON TWO TYPICAL  
TWO-STORY-AND-BASEMENT WOOD-FRAME HOUSES

# **EFFECTS OF AN ATOMIC EXPLOSION ON TWO TYPICAL TWO-STORY-AND-BASEMENT WOOD-FRAME HOUSES**

Federal Civil Defense Administration  
Washington, D. C.  
September 1953

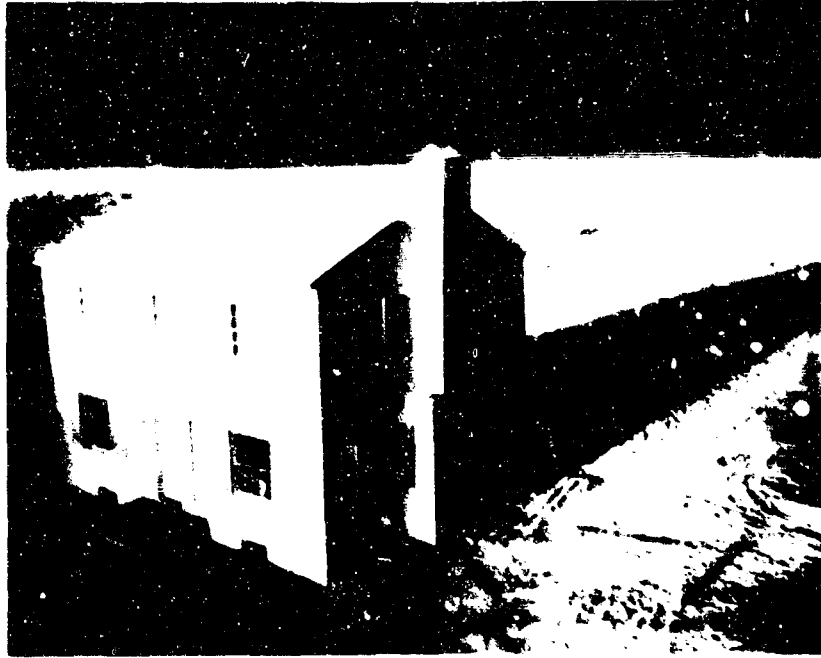
Fig. 1.1—House at 3500 ft, zero time, instant of detonation. The blinding light from the detonation throws the house, the desert, and the surrounding hills into sharp relief.

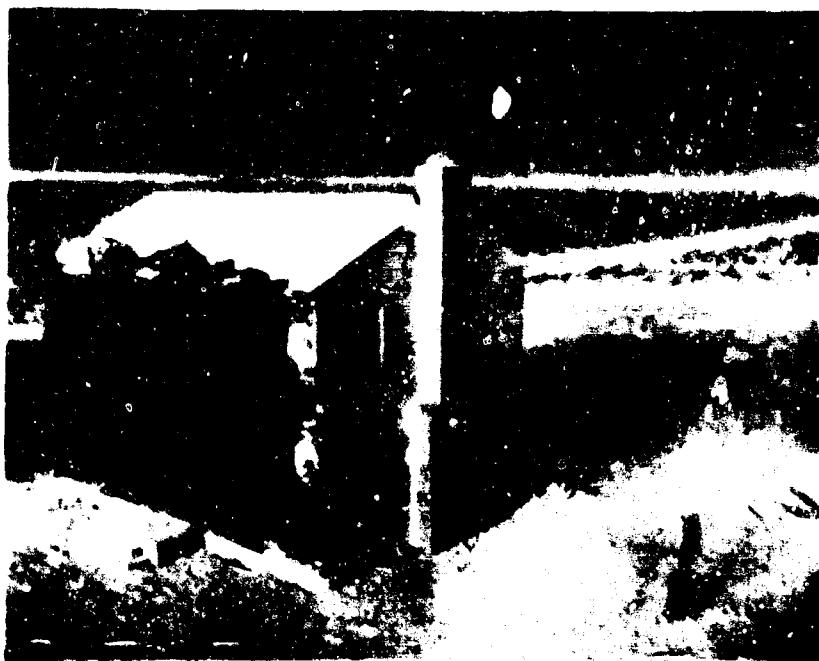
Fig. 1.3—House at 3500 ft,  $1\frac{18}{24}$  sec after detonation. The front of the house is almost obscured by smoke.

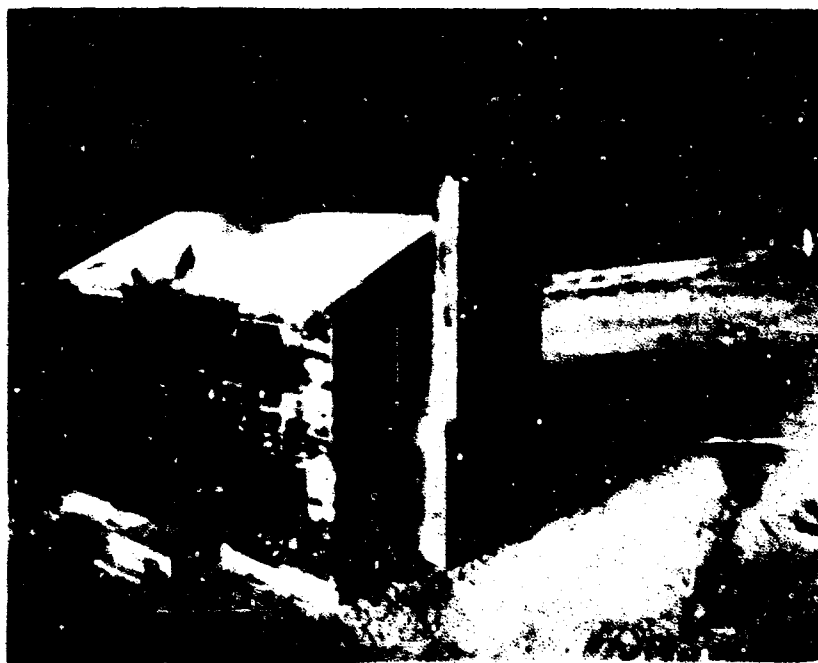
Fig. 1.4—House at 3500 ft,  $1\frac{18}{24}$  sec after detonation. The smoke is virtually gone.

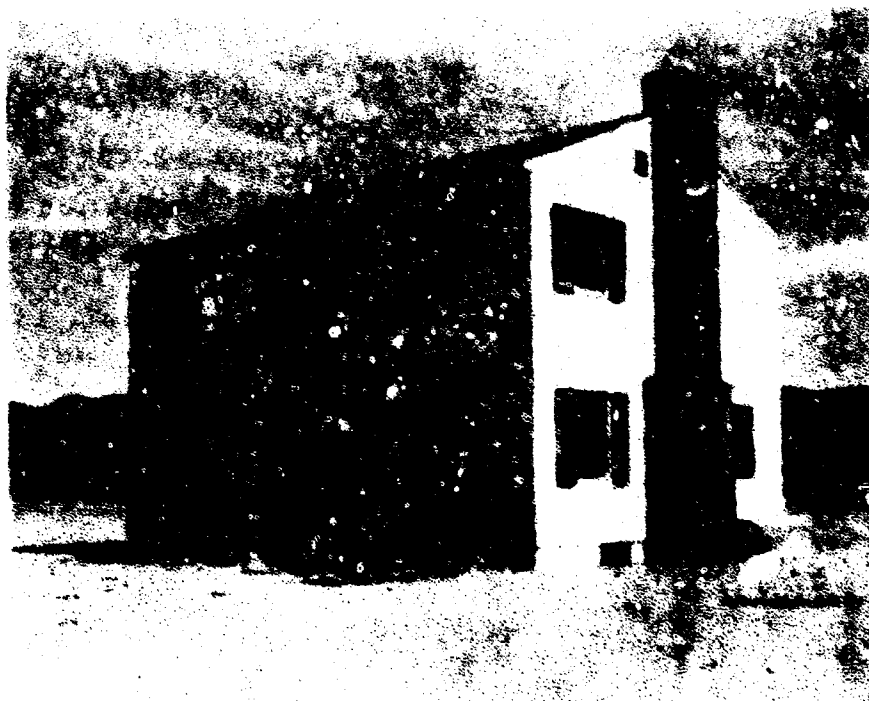
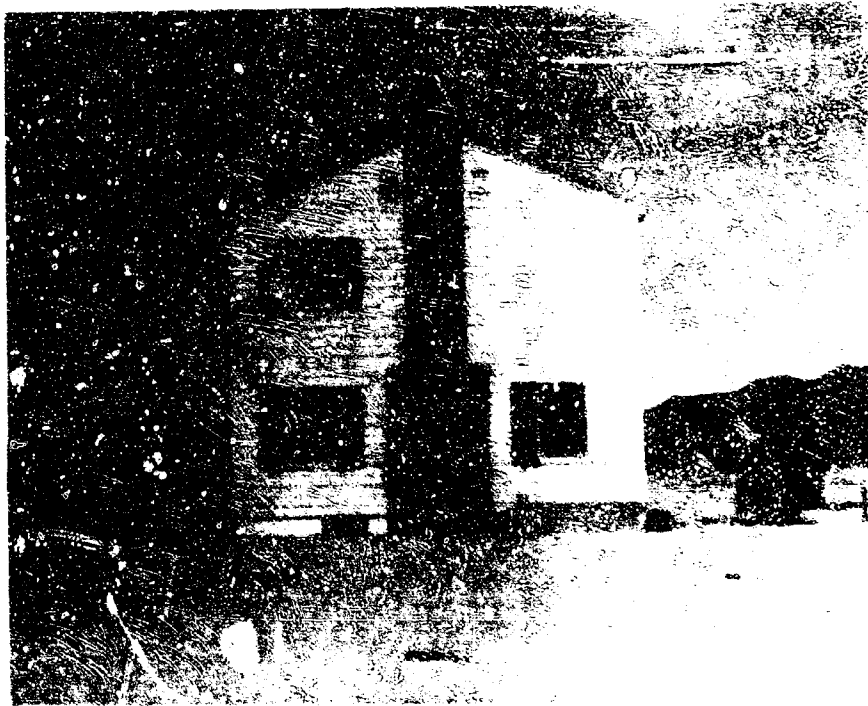
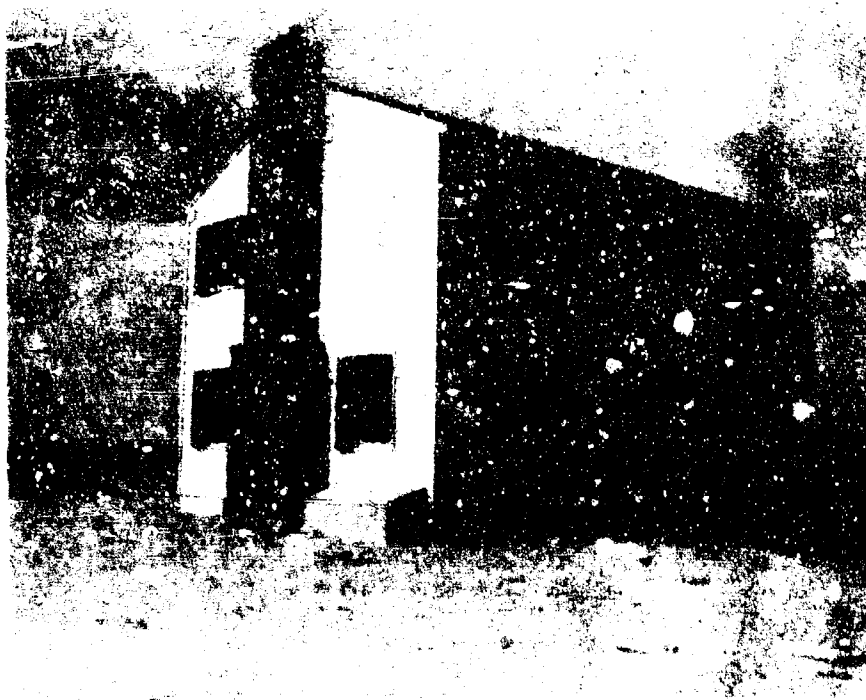
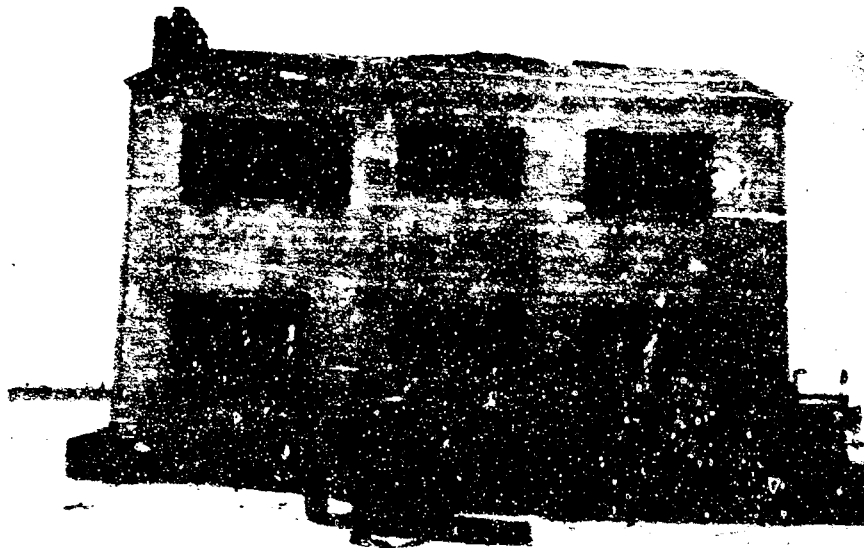
Figures 2.1 and 2.2 show the far-range house before and after the blast. Figures 2.3 to 2.6 show blast damage from the outside on sides and rear of the house. Doors, windows, and window frames in general either were blasted out of the walls or remained in place in badly damaged condition. The glass in the windows was shattered into small particles and scattered uniformly about the interior of the house. The exceptions to the general rule were four windows in the rear of the house, which had been sheltered by partitions from the blast that entered through the front and side openings, and the basement windows in the rear of the house, which were blown open inward.

Fig. 2.2—House at 7500 ft after the blast.

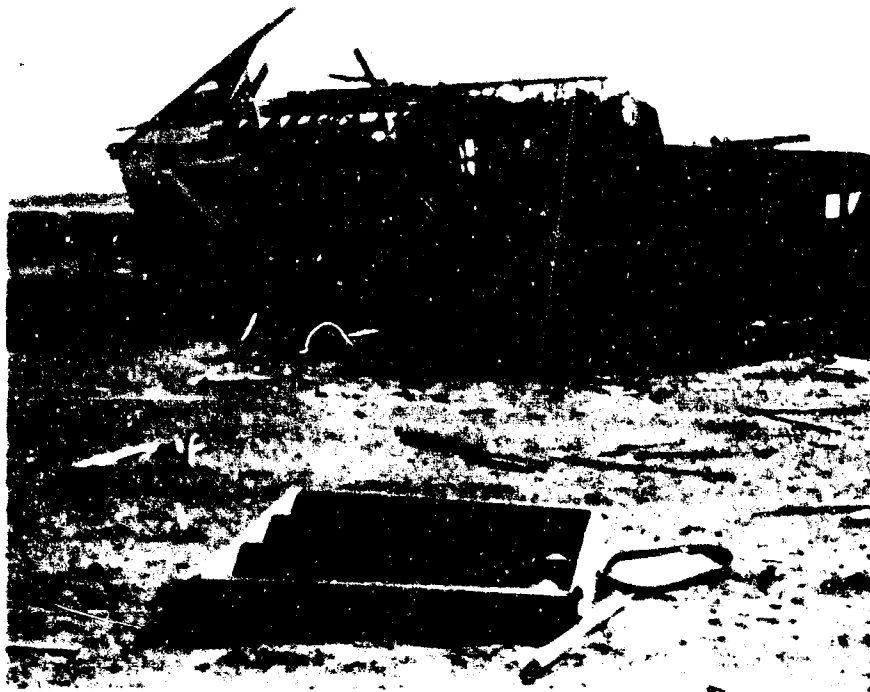
Figure 2.37 shows the front (facing the blast) of the near-range house before the explosion. Figure 2.38 shows a general view of the house after the blast, taken from about the same point. Moving around the house from the front counterclockwise, the damage is shown on the other three faces in Figs. 2.39 to 2.41. In the foreground of Fig. 2.41 the floor of the kitchen entrance is shown in an upside-down position. The house was demolished beyond repair.

Fig. 2.39—Side of the house at 3500 ft.

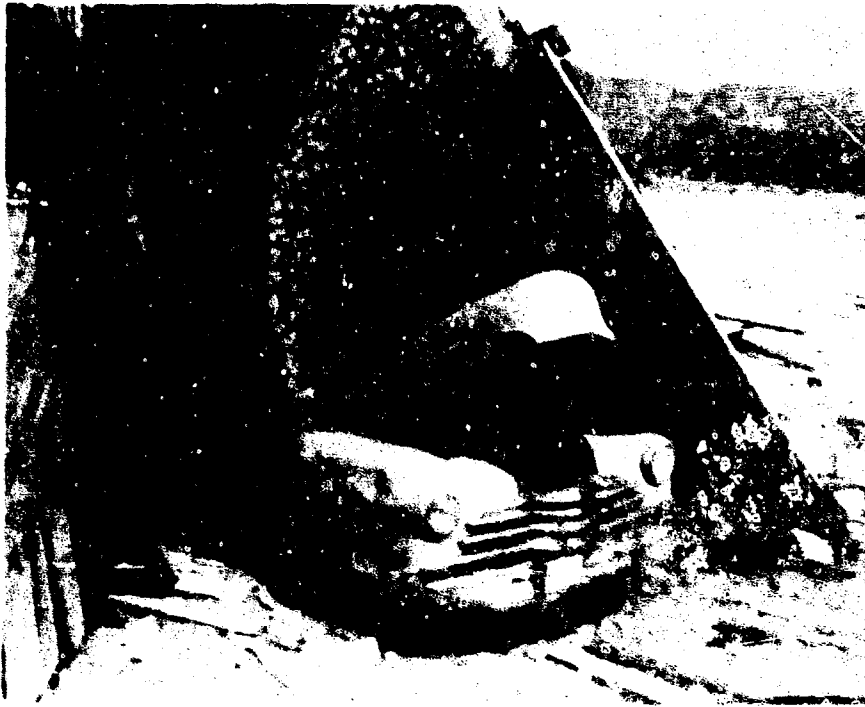
Figure 2.42 shows the large area over which debris was scattered. The front half of the roof broke in the middle at approximately the midspan of the rafters, the lower part lifting at the eaves, as shown by motion pictures, pivoting about the break, and sailing through the air to land on the ground in the rear of the house (see Fig. 2.43). The upper part of this broken roof was found upside down on the ground in front of the house, as shown in Fig. 2.44. The rear half of the roof slid off the house to the rear over a test automobile shown in Fig. 2.45. This section was later laid on the ground at the back of the house and can be seen in Fig. 2.43.

Fig. 2.45—Rear section of the roof.
